GREENE COUNTY CORNER PERPETUATION RECORD

Corner ID: Center_L19

Section 14- T07N-R03W, 2nd P.M.

Center Township, Greene County, Indiana

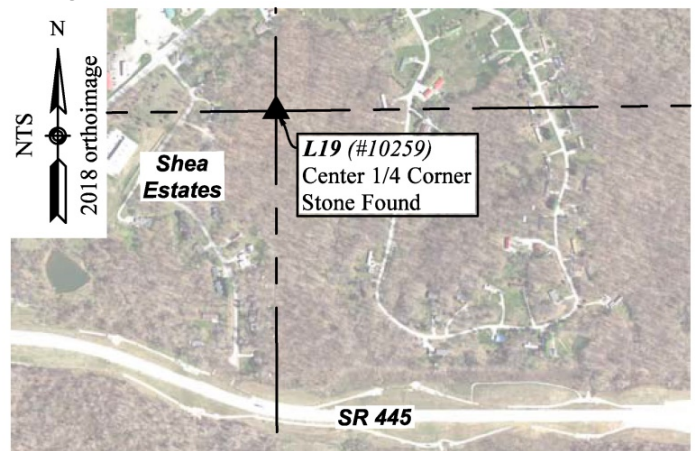
Photo Orientation & Description: Stone at L19

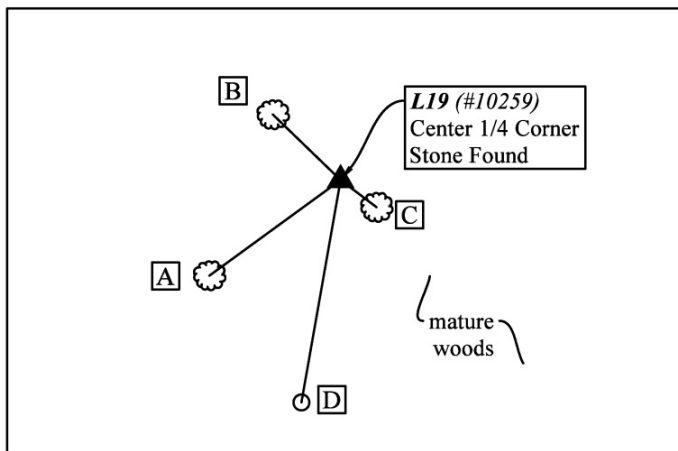
Photo Orientation & Description: Looking east at L19
